Manhole Inspection Summary

Manhole # S25UU1001MH

Insp Date: **5/3/07 5:10 PM**

Location Address: **303 CLUB RD**

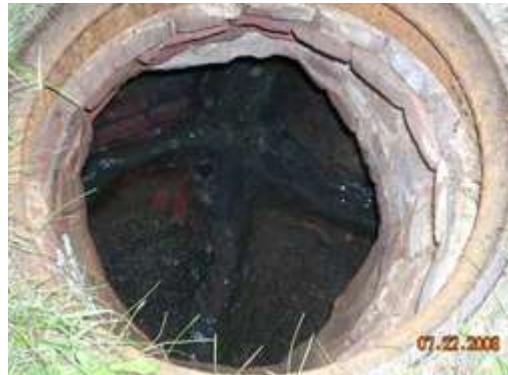
Comments **The Top View picture is the best we could get due to an overhang.**

☒ **Evidence Of Surcharge**

Depth: **1** (ft.) ☐ Active Surcharge Present

Evidence of surcharge - Bench debris.
Channel debris.

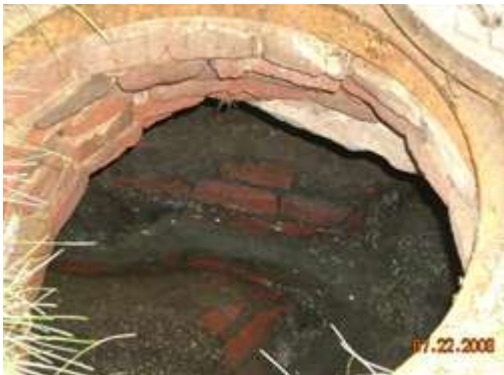
Defect

Condition: ☐ Sound ☐ Cracked ☐ Root Intrusion ☐ Loose Brick ☒ **Deteriorated**

Infiltration: ☐ None ☒ **Joint** ☐ Cracks ☐ Mortar ☐ Roots ☒ **Wall**

Infiltration: ☐ None ☐ Joint ☐ Cracks ☒ **Mortar** ☐ Roots ☒ **Wall**

Infiltration: ☐ None ☐ Joint ☐ Cracks ☐ Mortar ☐ Roots ☒ **Wall**

Adjustment and Corbel deterioration and
infiltration. Barrel infiltration - other side.

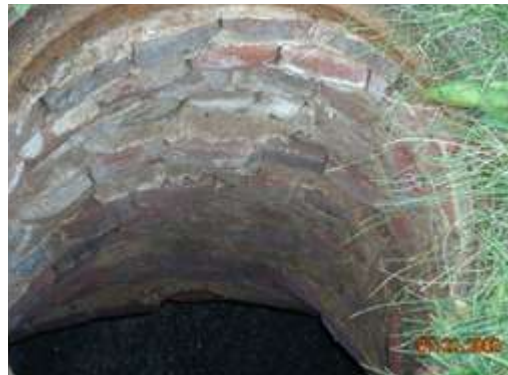
Defect

Adjustment and Corbel deterioration and
infiltration. Barrel infiltration.

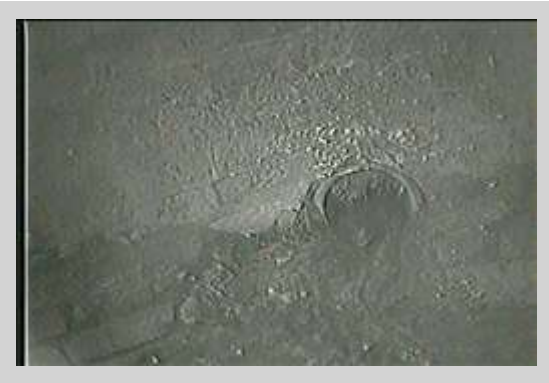
6 in. Circular Gravity Sewer Pipe Out @ 12 O'Clock

Infiltration: **Evidence** Pipe Seal Cond: **Roots**

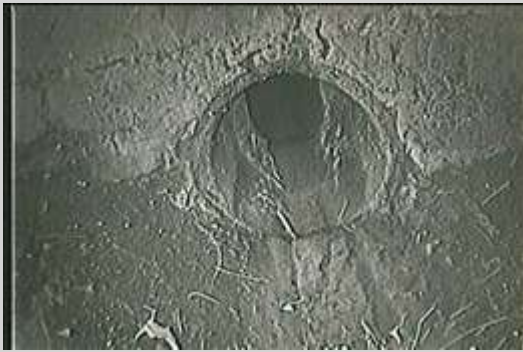
Pipe In @ 6 O'Clock

Infiltration: **Evidence** Pipe Seal Cond: **Roots**

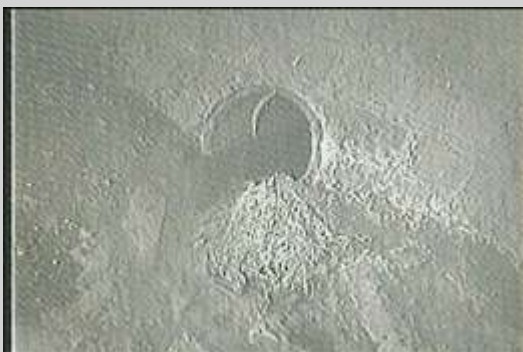
Pipe In @ 9 O'Clock

Condition: ☐ Sound ☐ Cracked ☒ **Root Intrusion** ☐ Deteriorated ☐ Leaks ☐ Debris

Channel root intrusion.

Infiltration: **Evidence** Pipe Seal Cond: **Roots**
